DELAWARE RIVER BASIN,
TAR HILL BROOK TRIBUTARY OF
PEQUEST RIVER, SUSSEX COUNTY,
NEW JERSEY.

LAKE LENAPE DAM

(NJ 00019)

PHASE 1 INSPECTION REPORT.
NATIONAL DAM SAFETY PROGRAM.

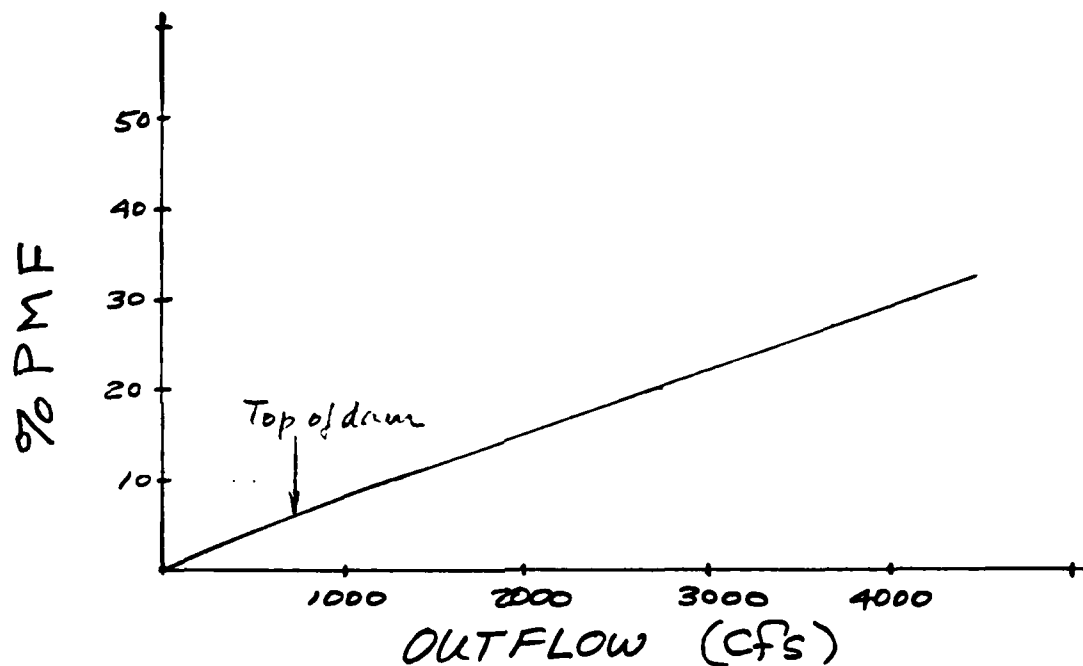
OVERTOPPING POTENTIAL

- 3) DAM OVERTOPS AT ELEVATION 109.1 WITH $Q = 739$ cfs. \therefore DAM CAN PASS APPROXIMATELY 6% OF THE PMF.
